Inspection Report

Client Name:	XXXXXXXX
To:	XXX
From :	TS INSPECTION SERVICES
Project No.:	HIE12110009
Report No.:	HIE12110009
Inspection Date:	17-NOV-12
Report Issue Date:	17-NOV-12
Vendor/Supplier:	XXXX (HK) ELECTRONICS CO. LTD
Factory Name:	XXXXX (HK) ELECTRONICS CO. LTD
Factory Address:	SHENZHEN
PO. No.:	20120/20119
Product Description:	10" MID TABLET 16:9/7" MID TABLET 16:9
Item/Product No.:	GBT1040RS/ GBT740RS
Order Quantity:	500PCS+500PCS=1000PCS
Available Inspection Quantity:	1000PCS
Order Cartons:	75CTNS
Sample Size:	32PCS
Destination Country:	UK
Origin Country:	CHINA
Service Type :	FINAL RANDOM INSPECTION
Re-inspection :	NO

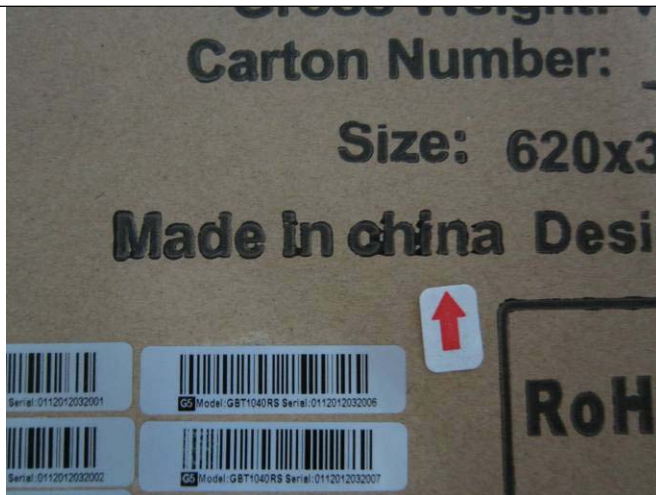
REMARK 9

1	The testing/measuring equipments applied during the inspection were all calibrated and within the period of validity. Yes (X); No ().
2	Client approved sample / inspection spec available for inspection reference at time of inspection: Sample: Yes (); No (X) -Factory Sample: Yes (). Client's Check list.: Yes (X), Packing list no.(PI. no.):_ / _____; Date: _ / _ / _ No ().
3	Actual instruction manual was conformed to the product inside. Yes (X); No (); N/A()
4	Actual gift box was conformed to the product inside. Yes (X); No (); N/A()
5	The brand name AND country of origin marking see section "T".
6	Shipping mark details please see photo attachment.
7*	Factory didn't provide connection device for inspector to test ethernet
8*	Factory did not provide equipment for high/low temperature test/ battery capacity/Hi-Pot test on adapter.
9*	GBT1040RS: slight poor printing on shipping mark.
10*	First digital of Bar code on gift box is not scanned out

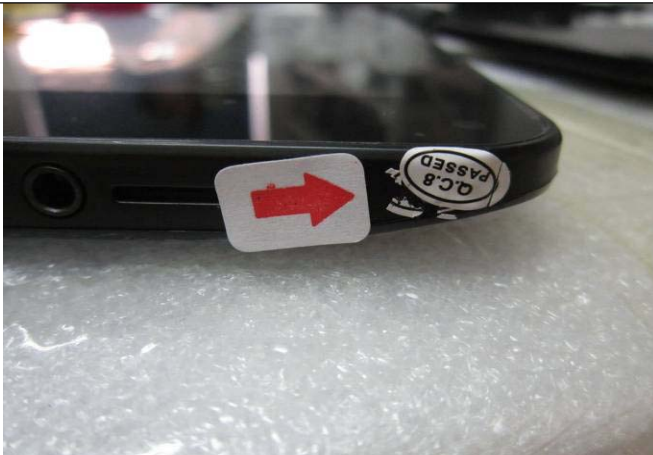
Description	Cri	Maj	Min
ITEM NO: (GBT740RS)			
Broken on QC label			1
Sometimes touch screen malfunction		1	
ITEM NO: GBT1040RS			
Display blue screen when tear up the touch screen protective film		1	
Screen flash /Unit dead when tear up the touch screen protective film		5	
Total Found:	0	7	1
Accept / Reject:	0/1	2/3	3/4
Result:	ACC	REJ	ACC

Broken on QC label

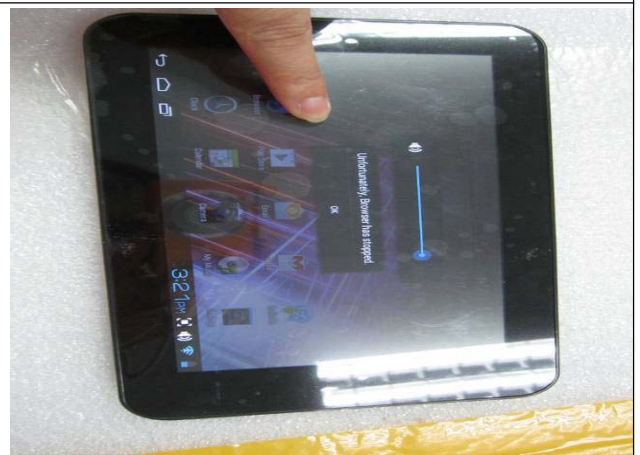
Sometimes touch screen malfunction

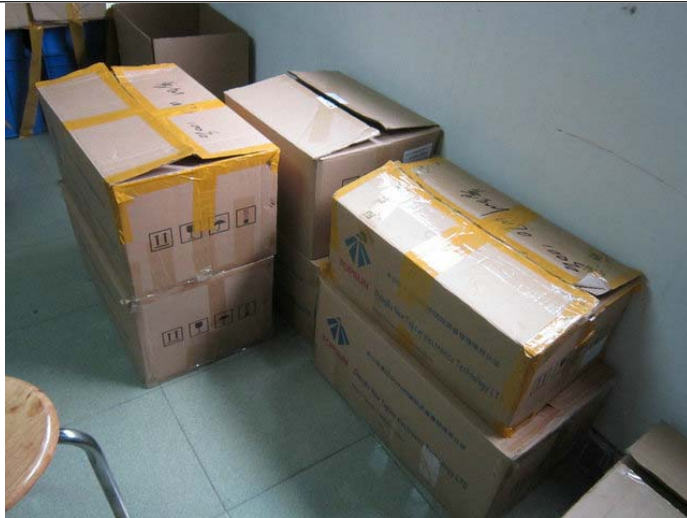
NON PACKED

11	WIFI test from minimum 25 metres-OK
12	Touchscreen typing test with low battery and touchscreen typing test when connected to mains with low battery-OK
13*	Production was 100% finished, but only packed 1 carton per item for packing inspection
